# PROJECT REPRESENTATIVE'S DAILY REPORT

Pg. 1  
Report No. 231  
Date: 2015-07-21  
Day: Tuesday

Project: Renovation and Addition to Tewksbury Town Hall

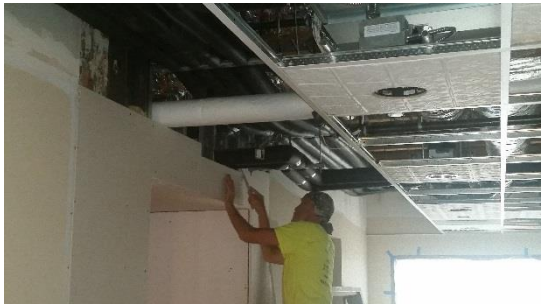
A photograph showing a carpenter in a yellow shirt installing drywall on a wall. The ceiling has exposed joists and some drywall is already in place.	<p>Carpenter installing drywall for the addition.</p>

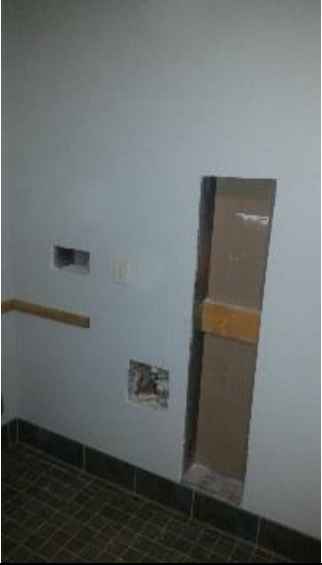
A photograph of a white wall with a doorway. A vertical piece of wood blocking is visible in the wall next to the door frame. There are also some electrical outlets and a small wooden shelf on the wall.	<p>Carpenters have installed wood blocking in walls for fixture attachments.</p>

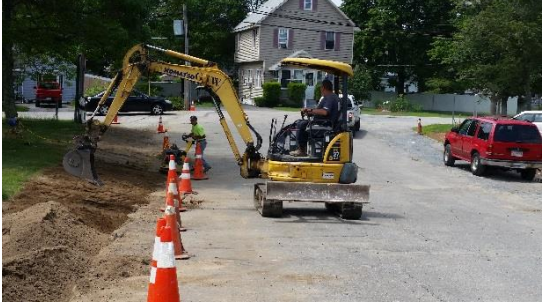
A photograph of a construction site. A yellow excavator is backfilling a trench. A laborer is standing nearby. Orange traffic cones are placed around the work area. A red car is parked in the background.	<p>Operator and laborer backfilling and compacting at new trench near the annex.</p>

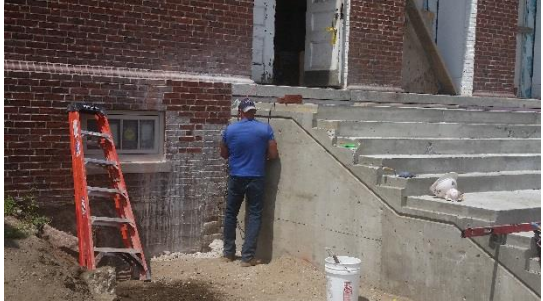
A photograph of a mason working on a brick wall. The mason is wearing a blue shirt and a cap. A red ladder is leaning against the wall. A concrete foundation and stairs are visible in the foreground.	<p>Mason working on brick wall near the front stairs.</p>

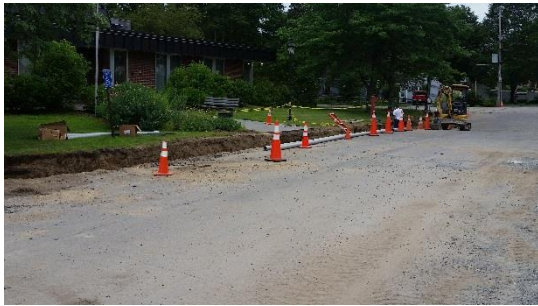
Electricians installing new communication conduit in the trench adjacent to the annex.

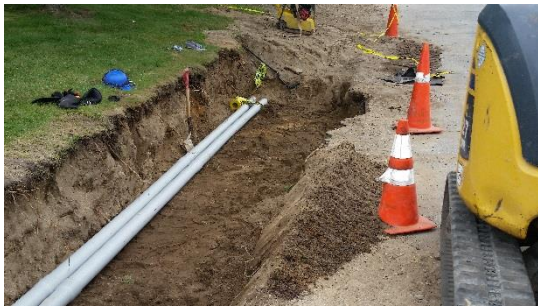
Completed communication conduit is being backfilled.

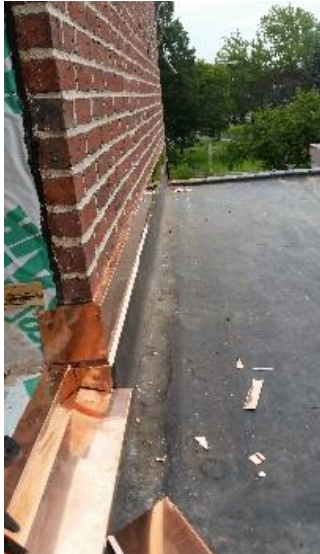
Roofers are installing copper counter flashing at the low roof/ upper wall at the main building.

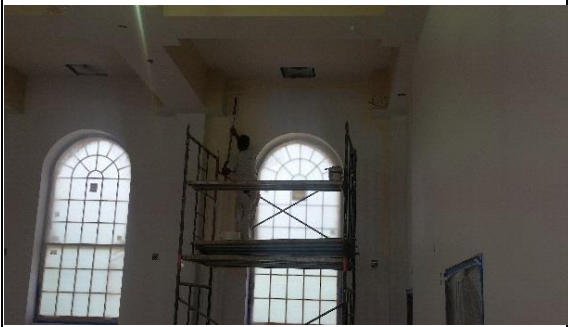
Painter is painting in the Meeting Hall.

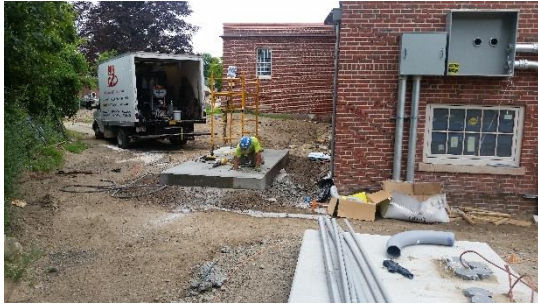
Pro Cut is cutting out a box out at the generator pad.

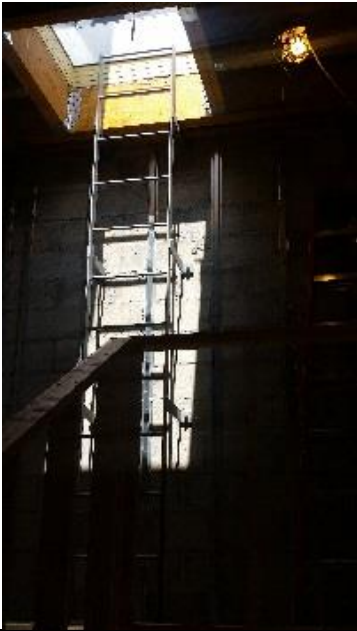
New metal ladder to roof hatch in the stairwell of the addition has been installed by miscellaneous metals subcontractor.
